Subject: **Queen Mary Inspection Report Update**

## Queen Mary Inspection Report Update

## QUEEN MARY

### April 26, 2021 Trip Report

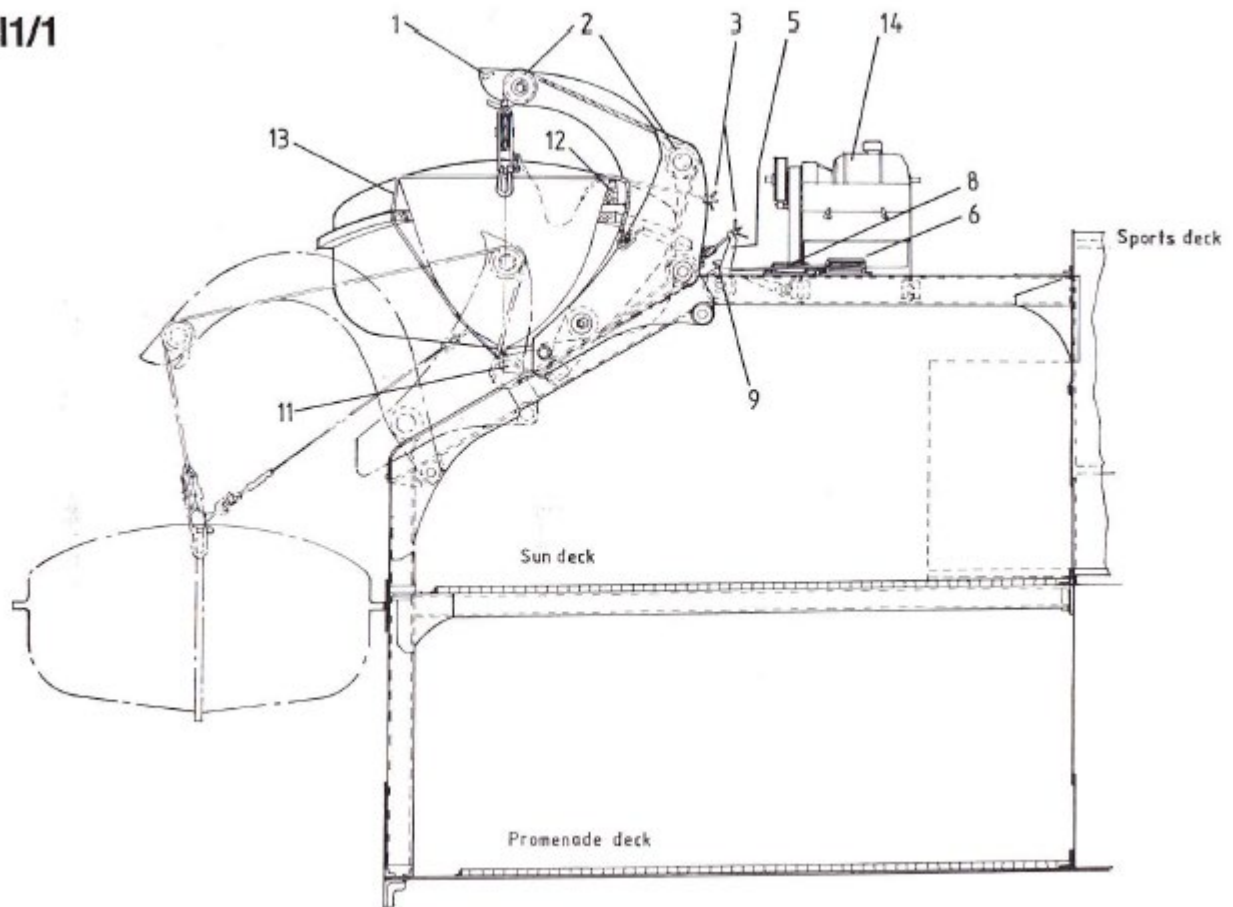
Figure 2 - Lifeboat Davit Arrangement (Watton) [4]

11. **Lifeboats** The lifeboats have not been changed since the 2015 survey. There are no covers on the boats. A number of lifeboats were briefly inspected, and no residual water was noted in the boats. A ladder was not available to check all of the lifeboats. The davit structure has severe corrosion for approximately twelve inches above the Promenade Deck (see Figure 2) where rainwater has been running down through the davit track.

Between 2015 and 2021 the Promenade Deck plating has continued to corrode and the strake between the strength deck fascia plate and the lower edge of the Promenade Deck windows has continued to corrode. This strake now has perforations the full length of the Promenade Deck. While this is not an immediate strength issue, it detracts from the vessels appearance and will continue to worsen until addressed. This plating also acts as part of the support for the lifeboat davit connection to the Promenade Deck.

k.	Remove promenade deck linings, store for reinstallation at later date and repair lifeboat davits using temporary structure. This will detract from the vessel appearance but will ensure that the davits do not deteriorate further. While failure would not be catastrophic, it would cause significant damage to the davit which would be difficult to repair. The lifeboats should be removed from the ship and either stored for restoration or disposal.	\$1,200,000		Assumes a temporary repair of 52 davit/promenade Deck side framing structures. This does not address perforated Promenade Deck shell plating, guttering, reinstallation of linings or other work.

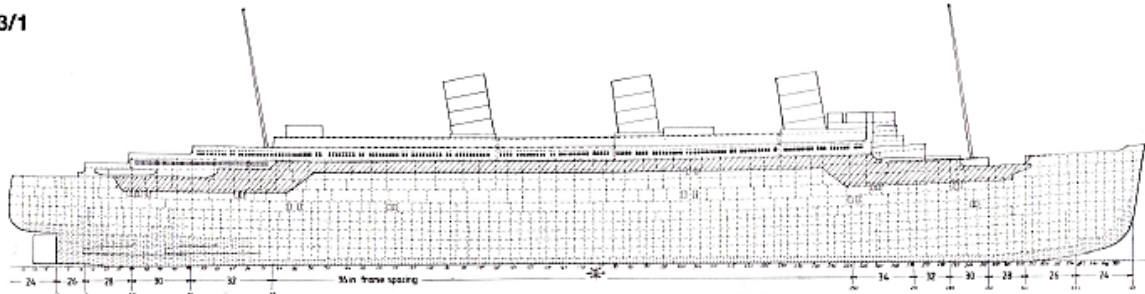
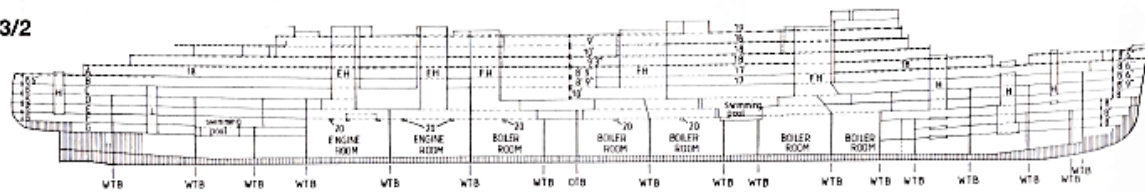
Figure 3 – Outboard & Inboard Profiles (Watton) [4]

- General inspection of the port side of the vessel from the dock (Reverse of Figure 3)
- Inspection of the port bridge wing and the port promenade deck. This included lifeboats and davits (Figure 2). It was not safe to board the lifeboats without determining the current condition due to the extensive corrosion.
- Inspection of the tank top area from the forward machinery space (FR 272) though the shaft tunnels at the aft end (FR 21). The tank top in the forward engine room (FR 112 to FR 136) was inspected from the tank top level, rather than from the scaffolding walkways at centerline. The shell plating and tank tops were locally inspected in the aft Engine Room (FR 86 to FR 112) and shaft tunnels.
- The steering gear flat was inspected internally.
- The propeller box was inspected internally and externally from the dock. The water was not drained from the propeller box.

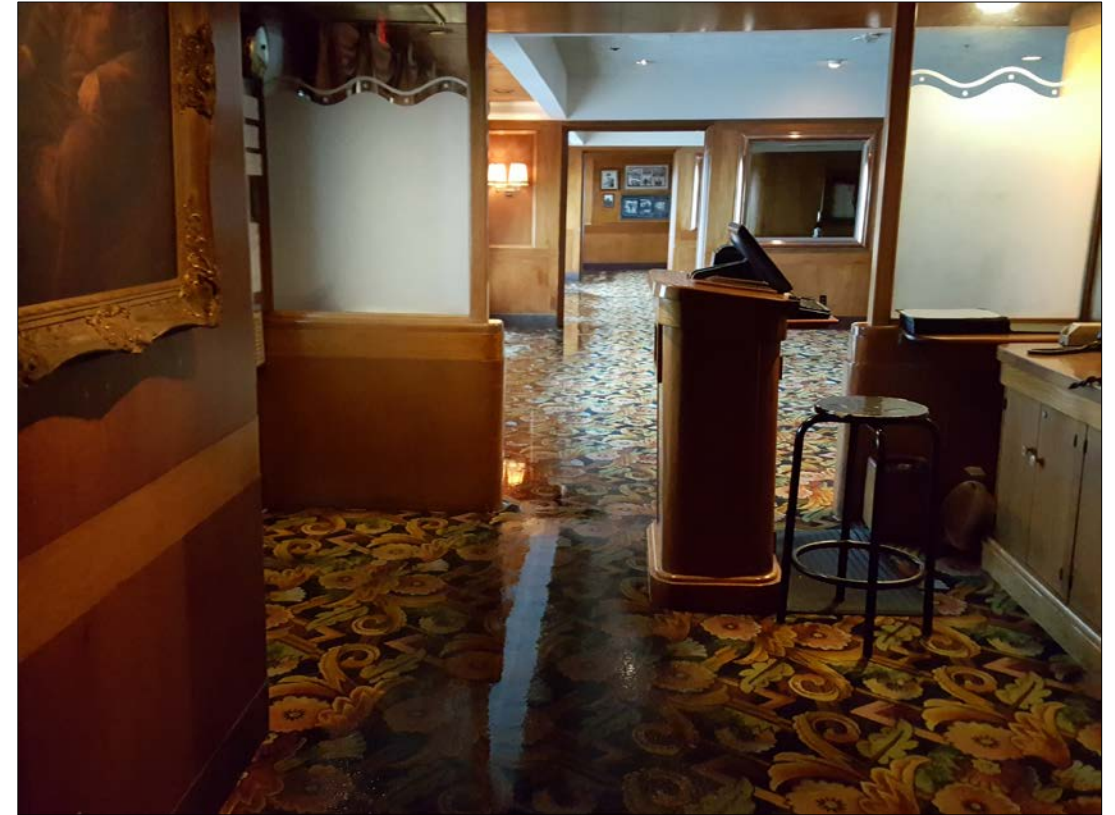
- To address water intrusion originating at the Top of House areas of ship.
- Before repairs could begin, severe storm in Winter 2017 inflicted significant damage
  - Closure of Sir Winston's Restaurant & Lounge, The Captain's Quarters, Wheel House & more
- Areas repaired include:
  - Cunard Room
  - Captain's Quarters
  - Executive Offices
  - Executive Office Roof
  - Bridge and M Deck
  - Frame 200

Storm damage at Sir Winston's

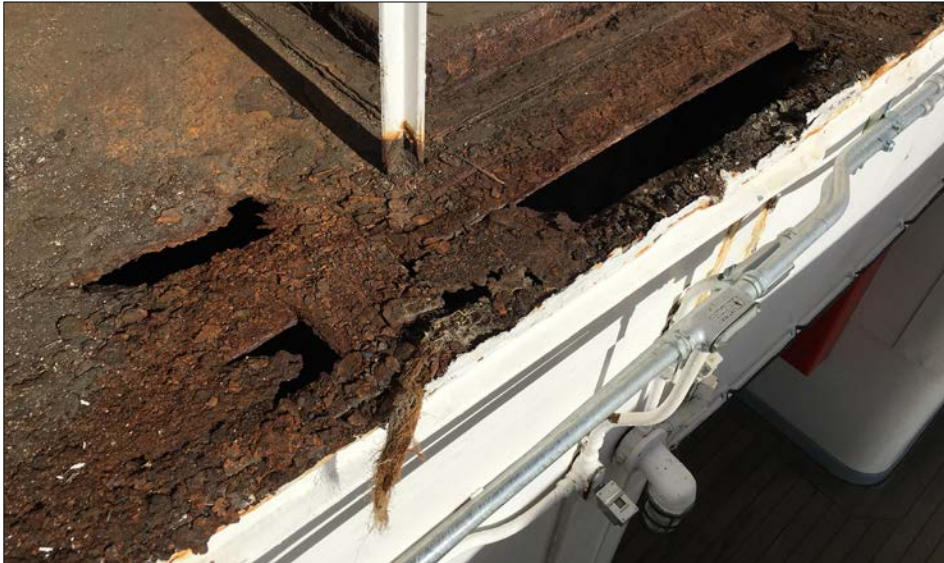
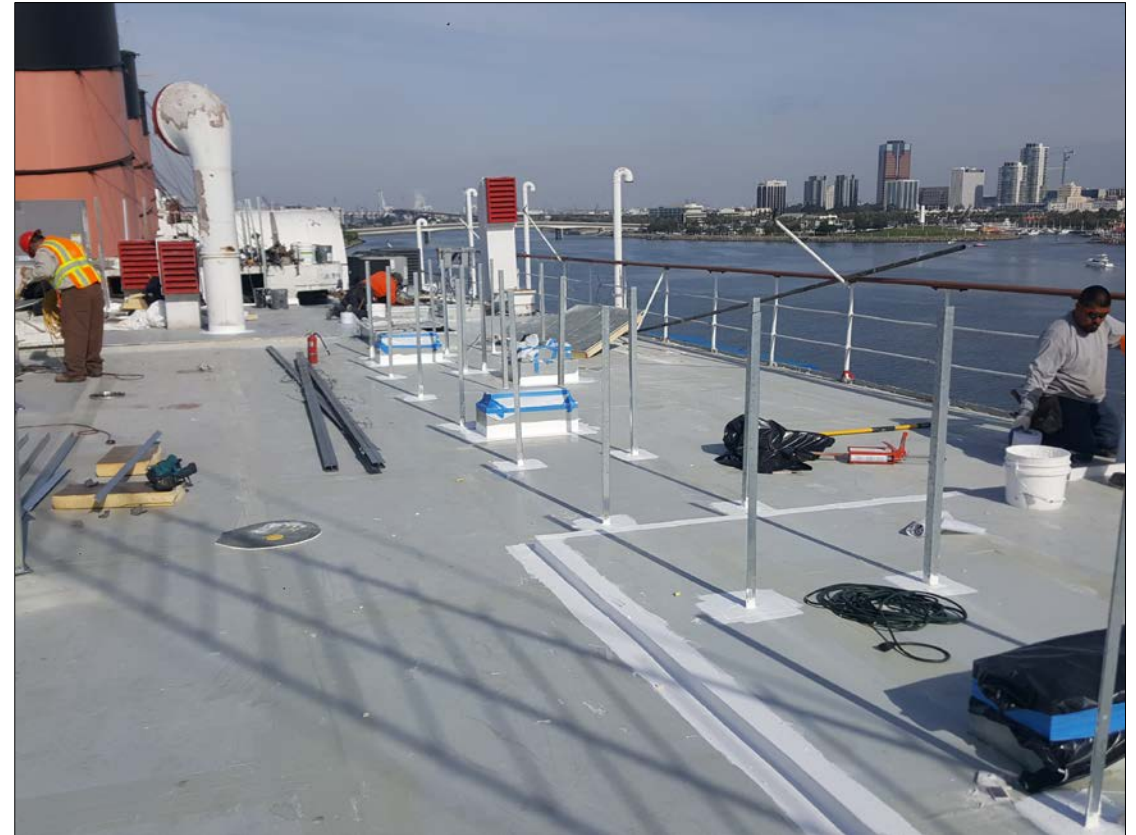
Roof damage and repair/waterproofing on Bridge deck (above Captain's Quarters)

- Roofs replaced and restored
- Rotting and leaking decks replaced
- Interior of spaces rebuilt

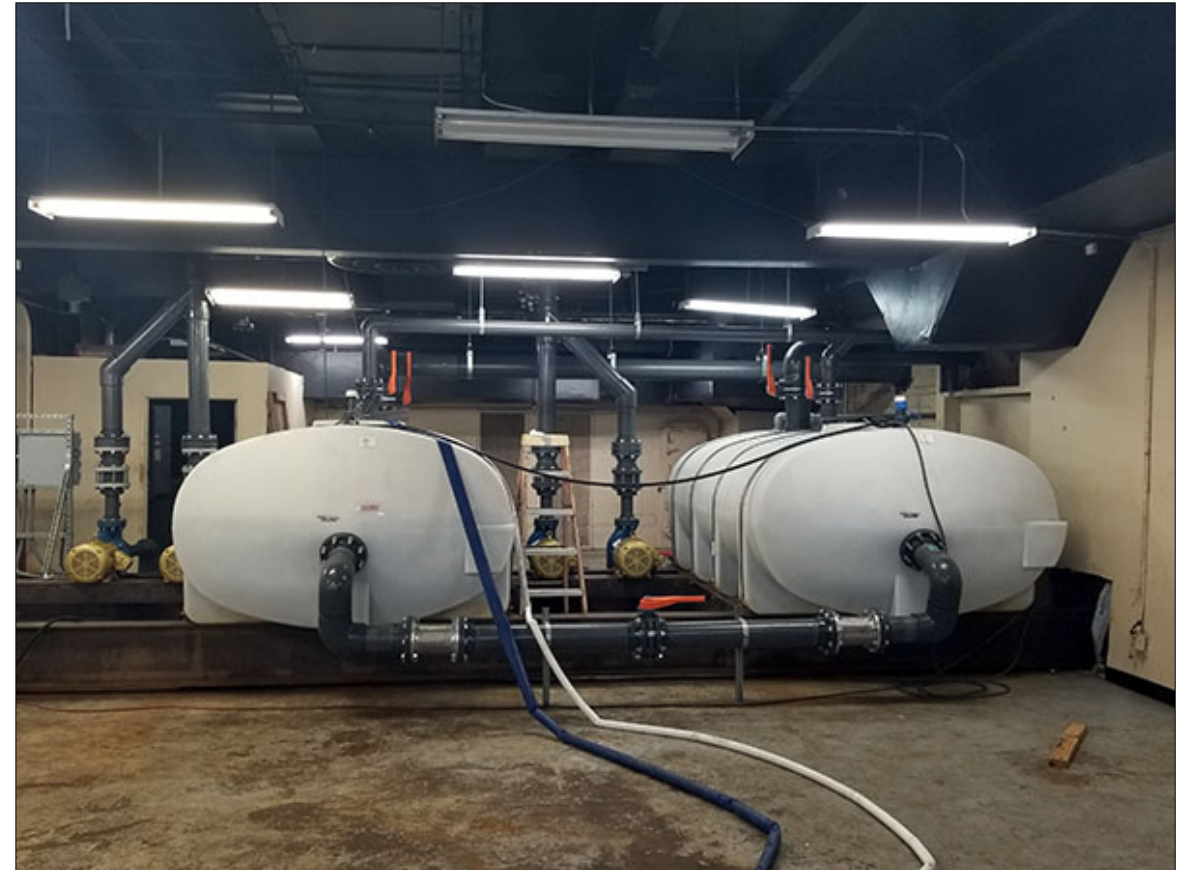
New temporary sewage tanks

- Temporary sewage tanks installed
  - Wing and bottom tanks drained, cleaned, taken off-line
- Plumbing line repairs
- Water removed from hull, area cleaned and sanitized

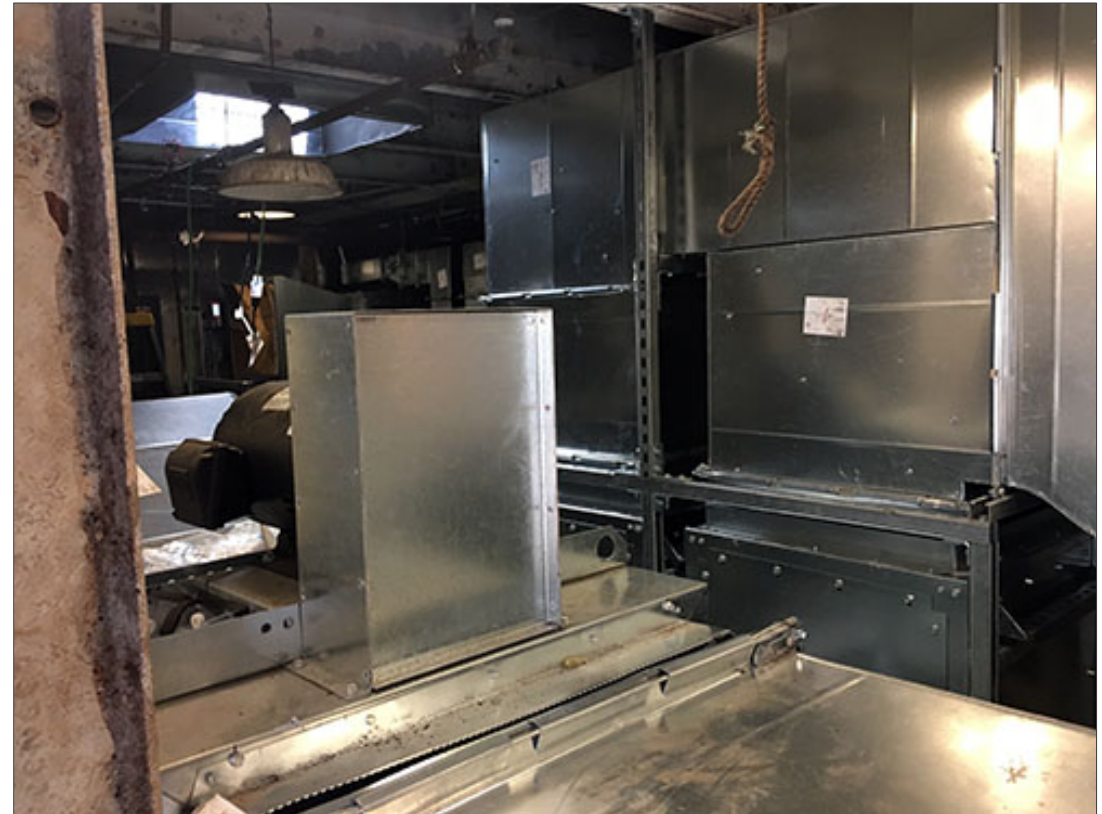
HVAC installation at Frame 200, top of house

- Contractor inspected systems, prepared recommendations
- New systems installed to eliminate top-of-house leaks
- Other repairs made at Exhibit Hall and King George Room

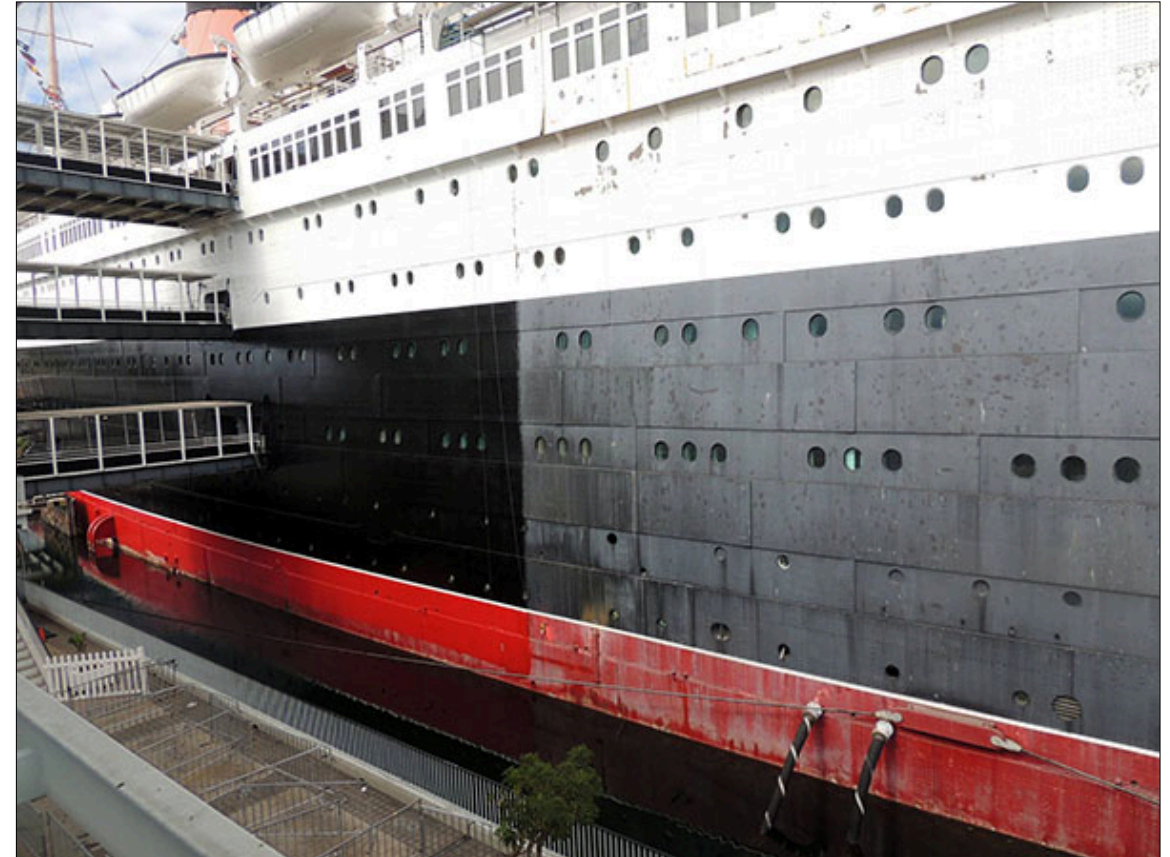
- Structural integrity compromised due to exposed and rusted metal
- Rust remediated, inhibitor applied and 240,000 square feet of hull primed and painted
- Restored to original and historic colors

Hull painting in progress

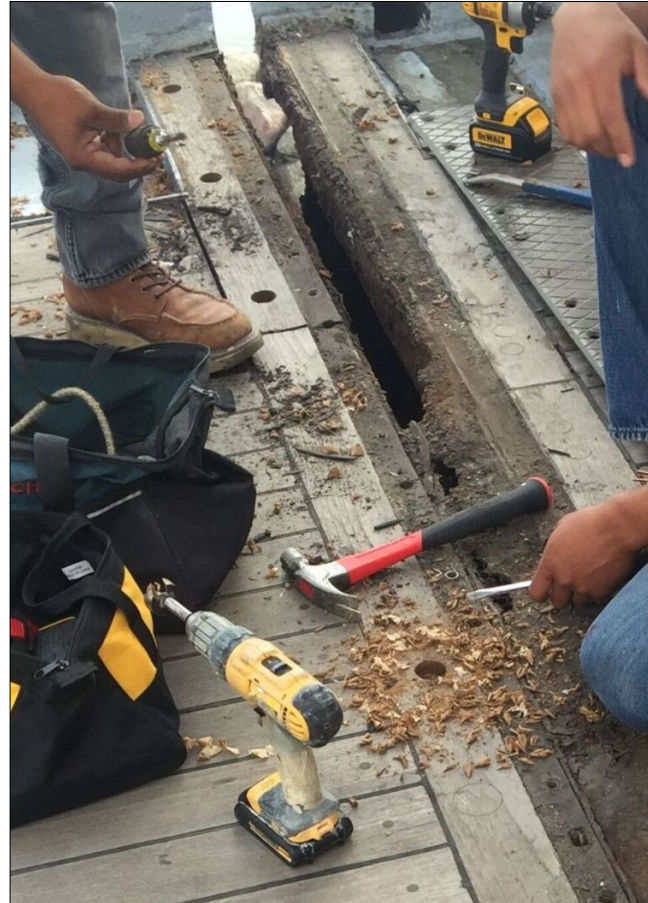
All three of the ship's expansion joints were extremely corroded and no longer watertight or structurally sound. The replacements were designed to be historically correct.

Before

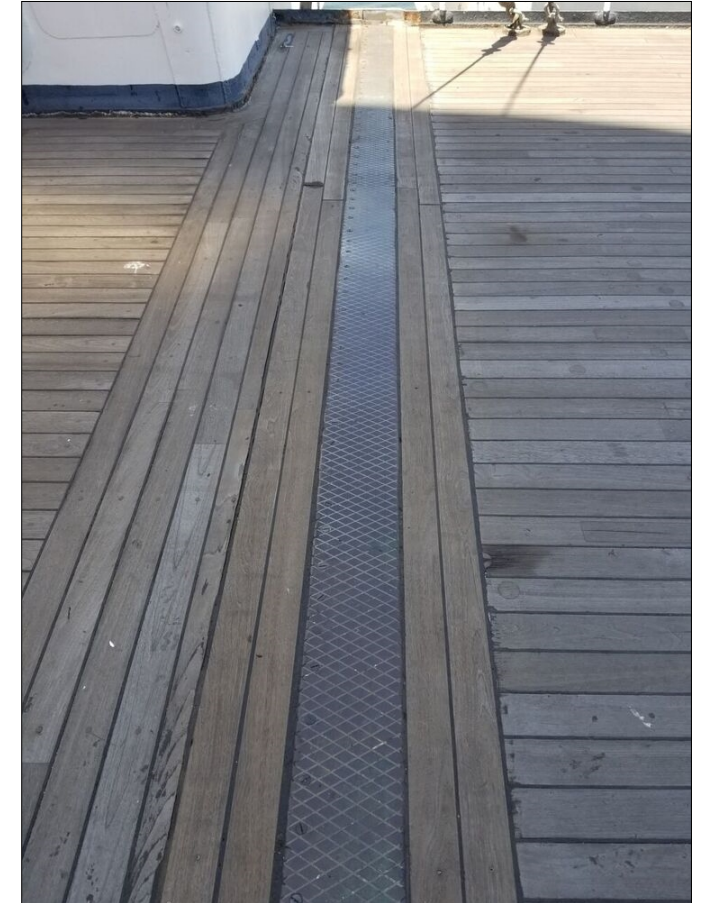
After

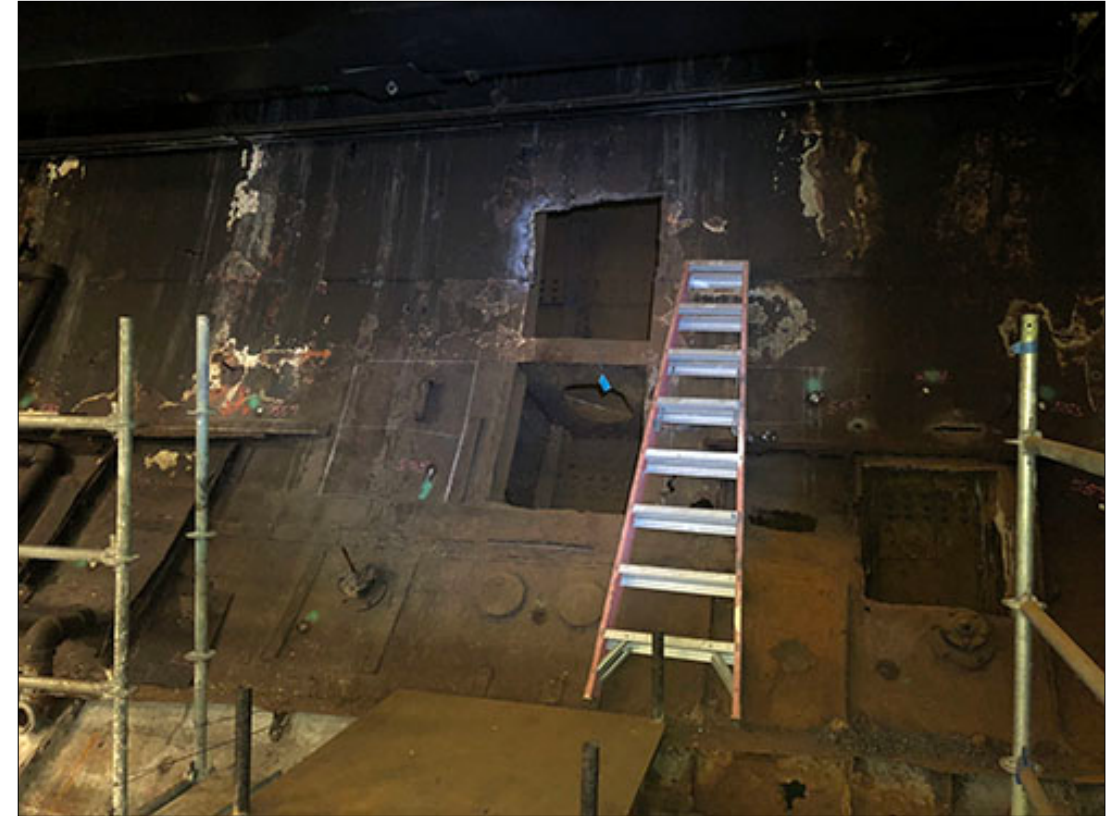
Side tanks repair in progress

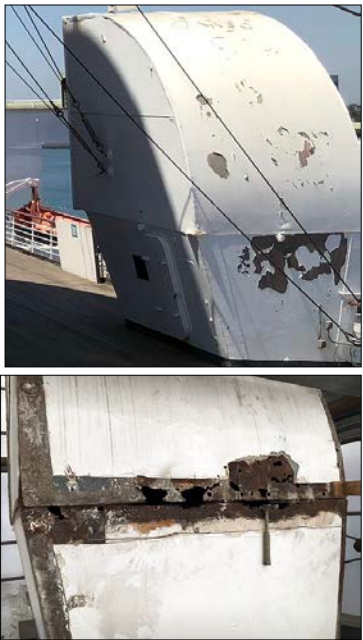
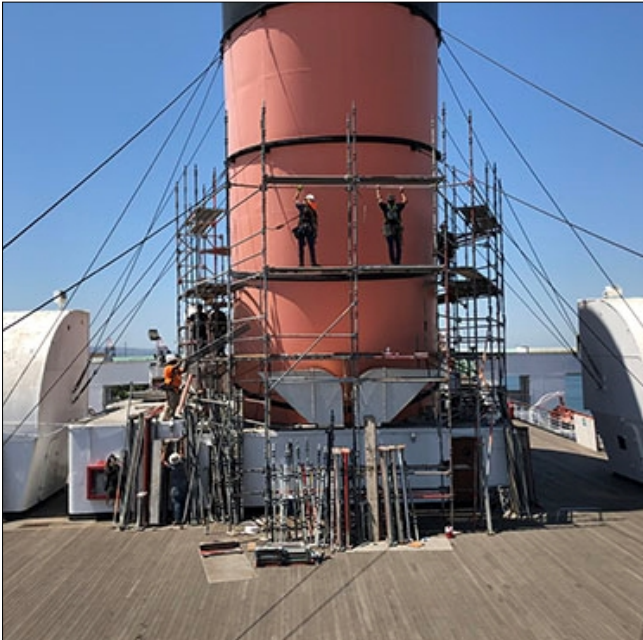
Intake vents and funnel before

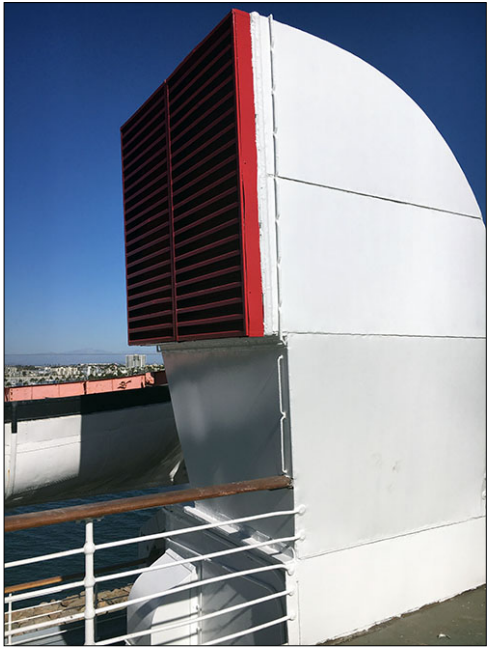
Intake vent and funnel after

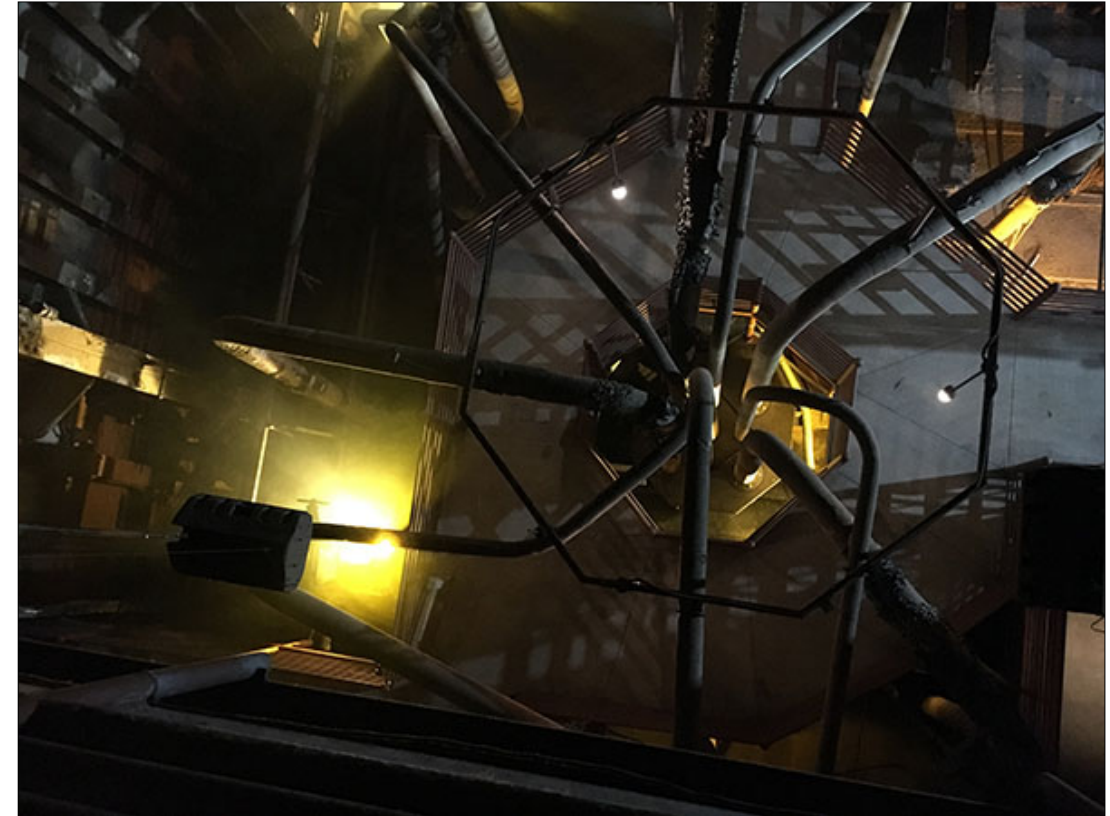
- Repairs in the area of Ghosts and Legends attraction
  - Area shut down in April 2016 due to structural issues
  - Marine Survey identified leaks in fiberglass pool as contributing to corrosion of bottom of ship
- Raised floors re-built, now safe to enter and attraction has re-opened

Re-built walkway structure, from above

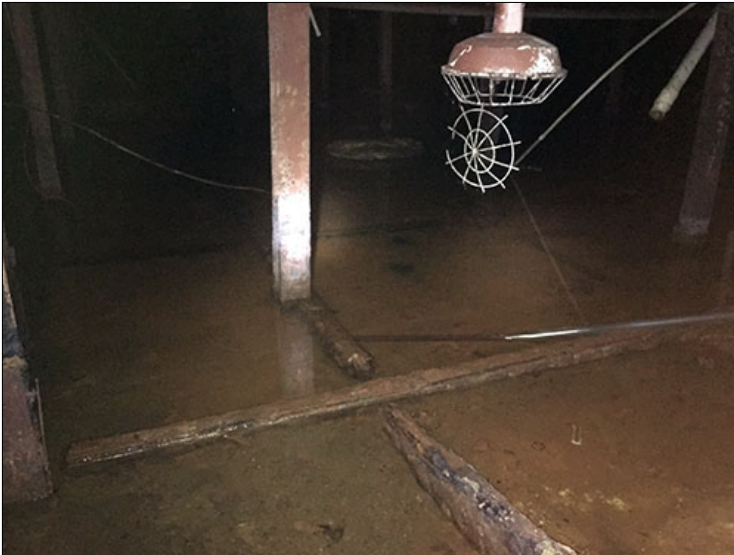
Ex Hall & Boiler Rms

- Demo of raised floor; de-watering, repair and rust abatement
