Subject: **Queen Mary Update**

QUEEN MARY

INSPECTION REPORT

REPORT DETAILS			
Document Number	L-HO-M10-030760-R04	Client Name	POLB
Revision	A	Client Reference	
Author	Sergiu Borsan	Issue Date	23-Jun-2023
Task Name	Inspection Report	Task Number	CTR 105

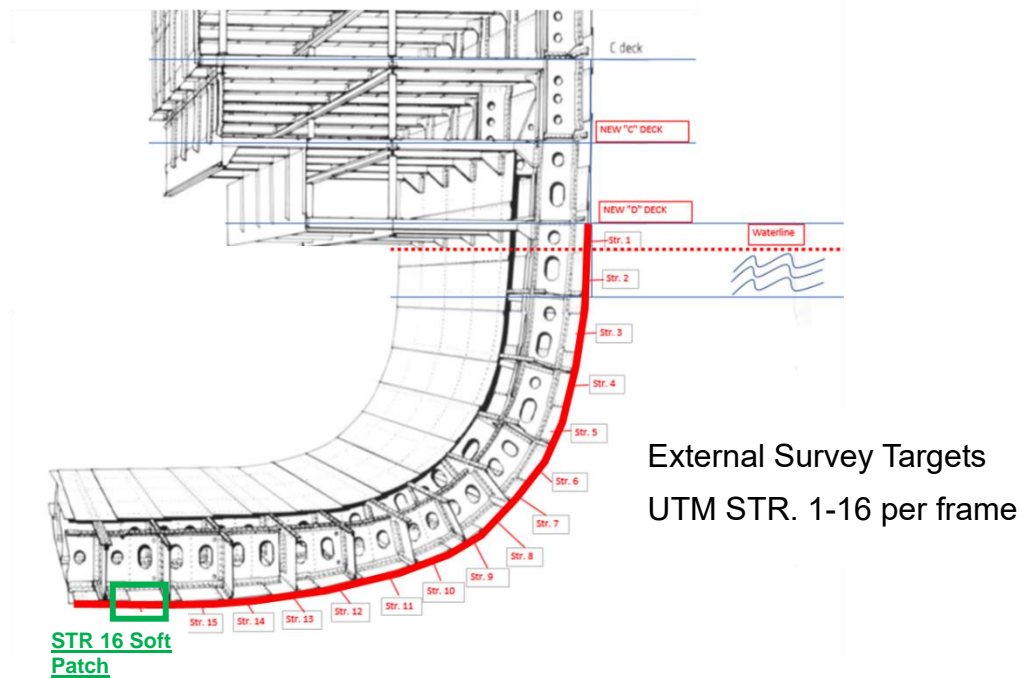
Figure 5-1: External Survey SoW Soft Patch Strake 16

A soft patch was identified between frames 34-38, strake 16 on the STBD side of the external hull corresponding to Double Bottom Tank P (See Figure 5-1 and Figure 5-2). Thickness measurements in two (2) locations of this area read 0.234 in (5.94mm) and 0.292 in (7.41 mm) respectively.

To maintain the watertight integrity of the hull, the soft patch should be repaired. If the soft patch is compromised allowing for water ingress, the entire engine room could flood. Since there are no watertight doors to separate compartments, the vessel could flood until grounding.

It is recommended to repair the soft patch by means of Sandwich Plate System (SPS).

Repairs are recommended in way of the engine room soft patch. The remaining thickness is no longer satisfactory and any water ingress in the engine room would lead to a severe incident considering the lack of compartmentalization onboard. Such repair can be done using SPS.

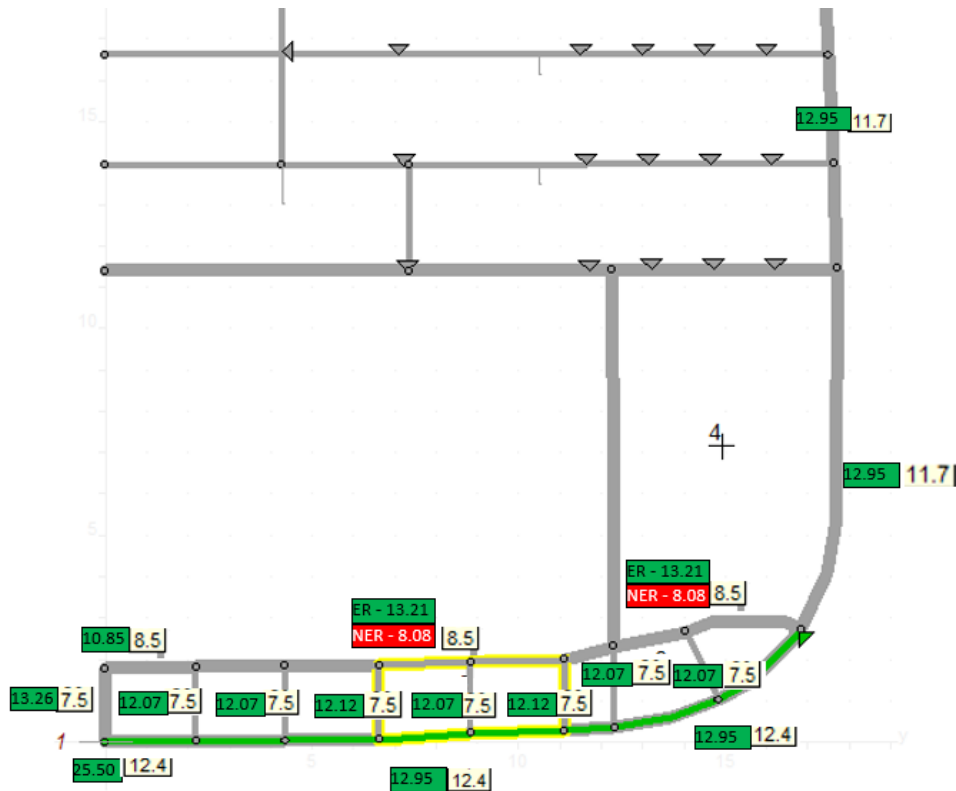
See Figure 5-4 below for a direct comparison between the cross section at 50% corrosion and minimum UT readings:

The minimum thicknesses measured in the double bottom section of the QM are above the LS thicknesses considered during the preliminary calculation of the longitudinal strength except for the inner bottom thicknesses in the non-engine room areas outboard of the keel. The thickness in non-engine room areas of the inner bottom considered in the calculations is 8.5mm whereas the UT measurement provided a minimum reading of 8.08 mm.

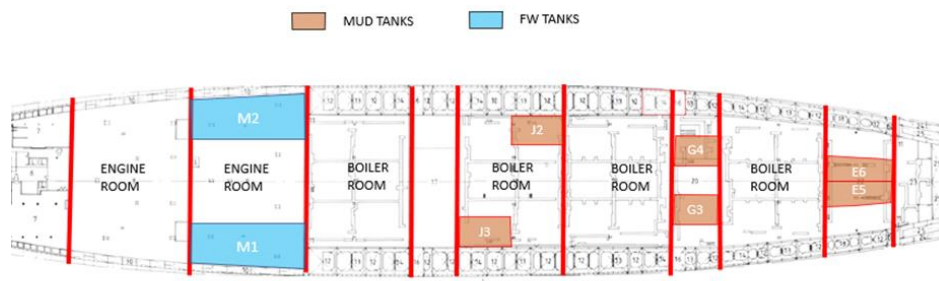
Figure 5-5: Inspected Double Bottom Tanks

In total, we have inspected eight (8) double bottom tanks distributed across the entire length of the vessel. The corrosion rate between the inspected tanks was consistent, therefore, we were able to surmise that the corrosion rate in the tanks that were not inspected would be similar.

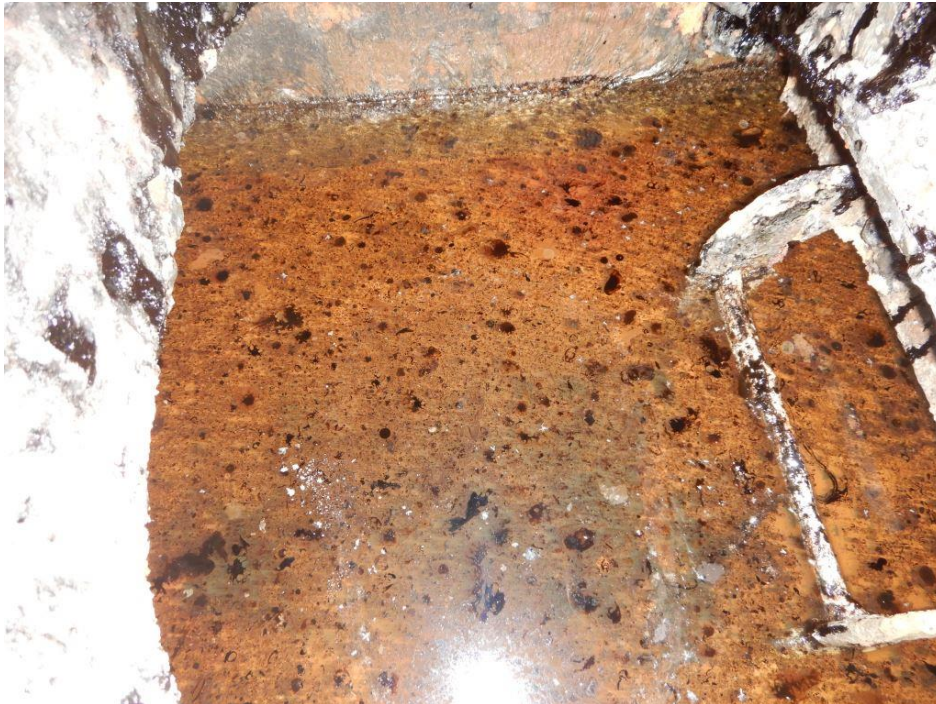
Figure 6-1: Aft Manhole Tank E5 - Original Mud Contents

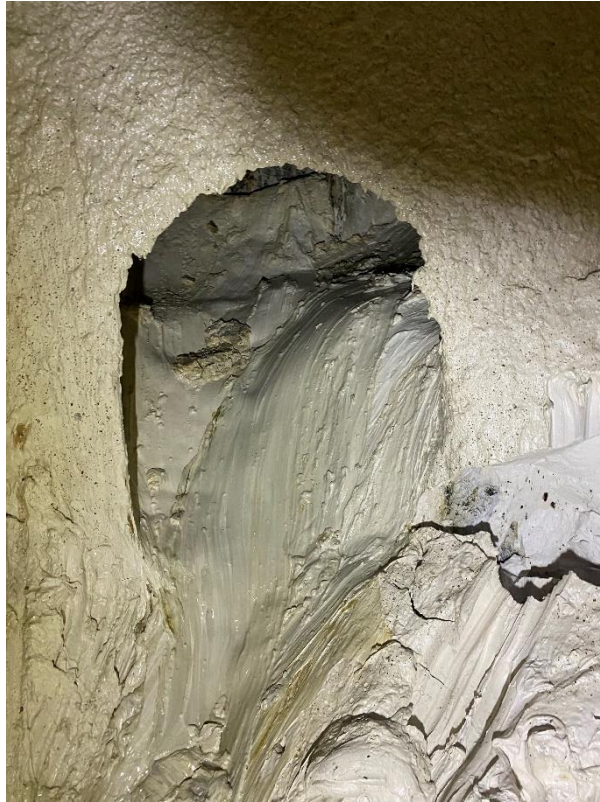
Figure 6-2: Mud Contents inside Tank E5

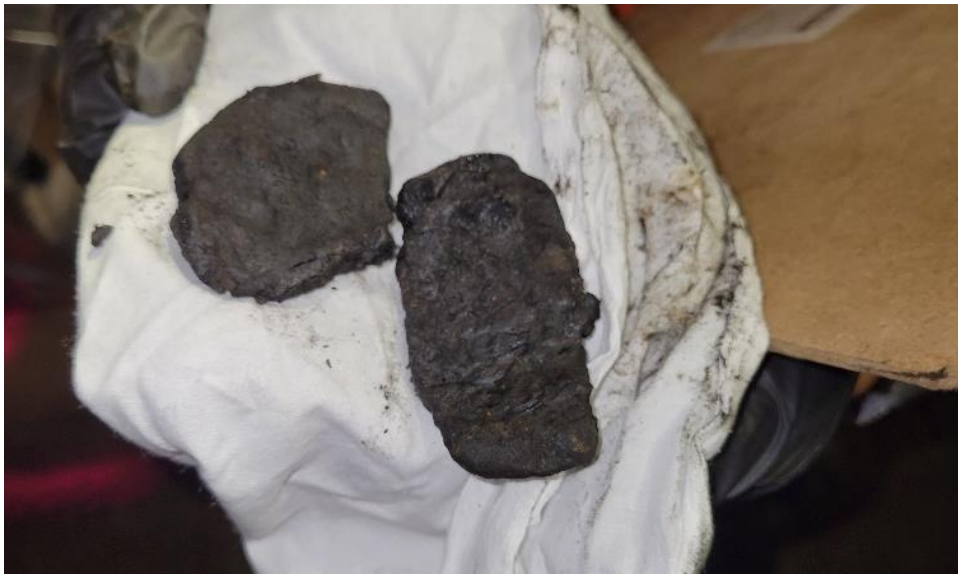
The pumps needed to be regularly checked for debris (steel bolts, nuts, rusted fragments, cement rocks etc) since there was a high chance of blocking the hoses and possibly damaging the equipment.

Figure 6-3: Tank G4 – Metallic Debris

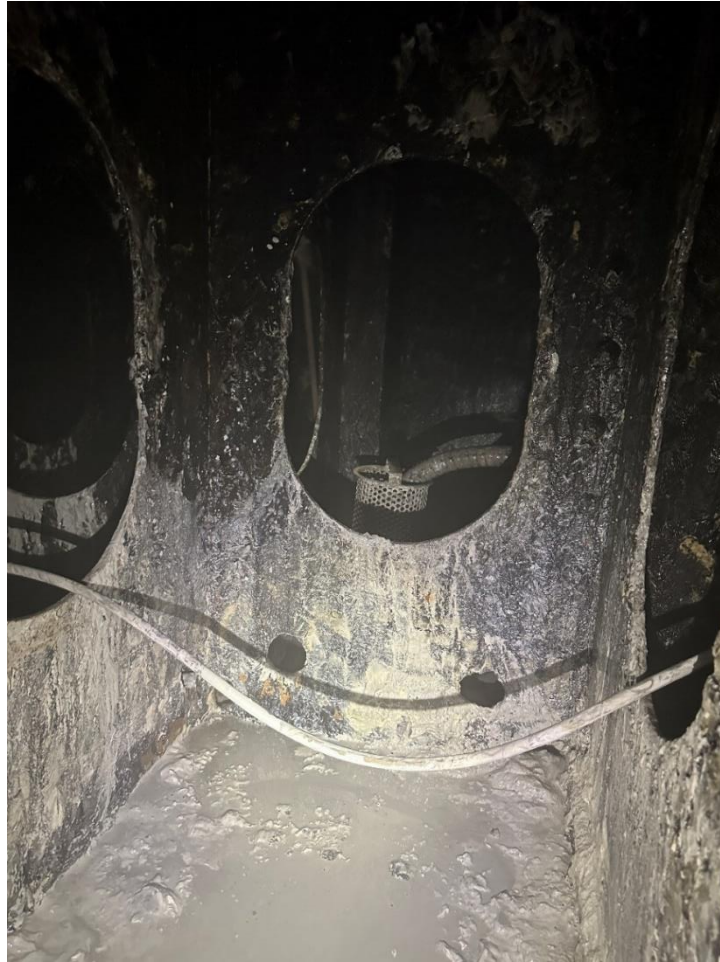
Figure 6-5: Mud Tank Compartment in E5 facing from CL to outboard (SB)

Longitudinal Girder Front; Transverse Girders Left and Right; Lightning Holes 30"x40" middle and 4" Ratholes bottom
