Subject: **Queen Mary Inspection Report Update**

## Queen Mary Inspection Report Update

## QUEEN MARY

### April 26, 2021 Trip Report

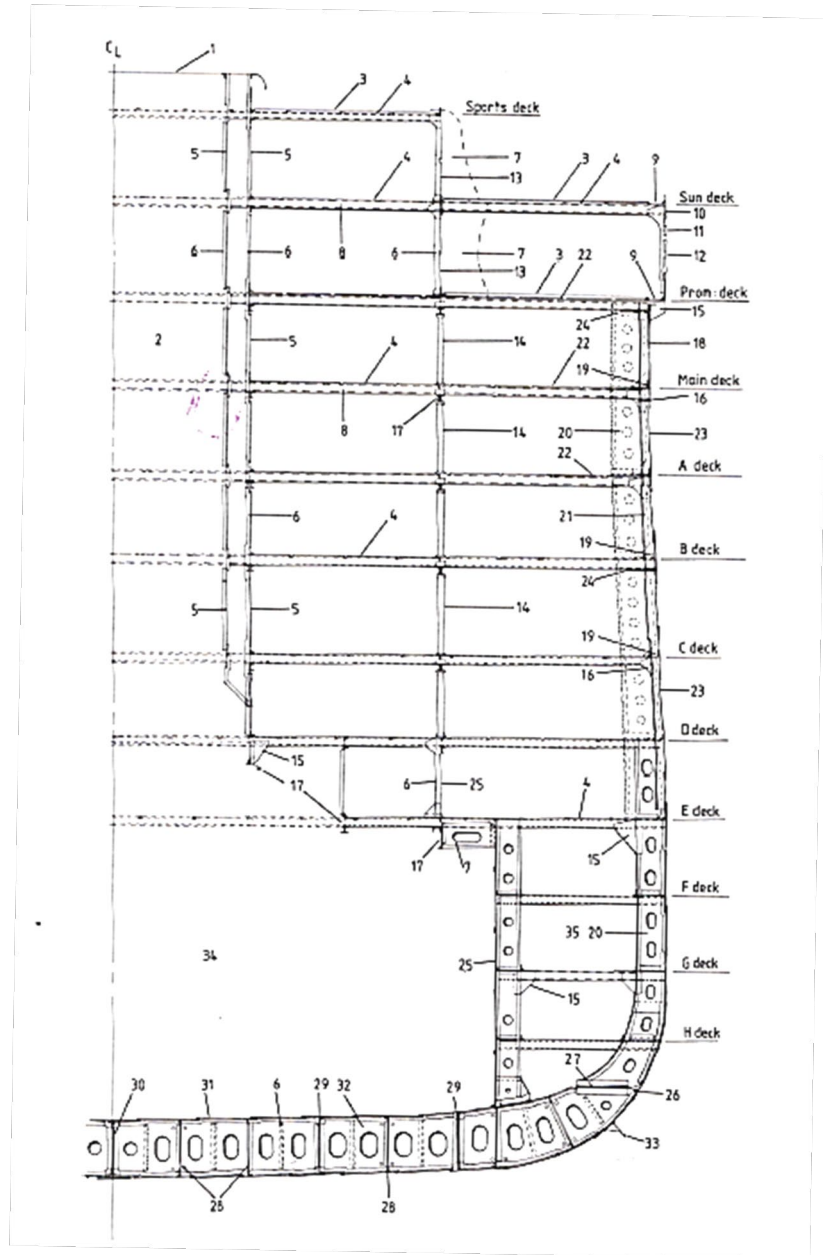
Figure 1 - Midships Section (Watton) [4]

In 1967 the vessel was moved to Long Beach, CA and converted to a visitor attraction. This involved removal of much of the propulsion machinery, structural bulkheads and modifications of the interior spaces to accommodate the vessels' new role. Many of the double bottom and wing tanks (Figure 1) were filled with a variety of liquids to maintain stability after removal of the machinery which was largely below the vessels vertical center of gravity. The vessel is berthed inside a rip rap breakwater in

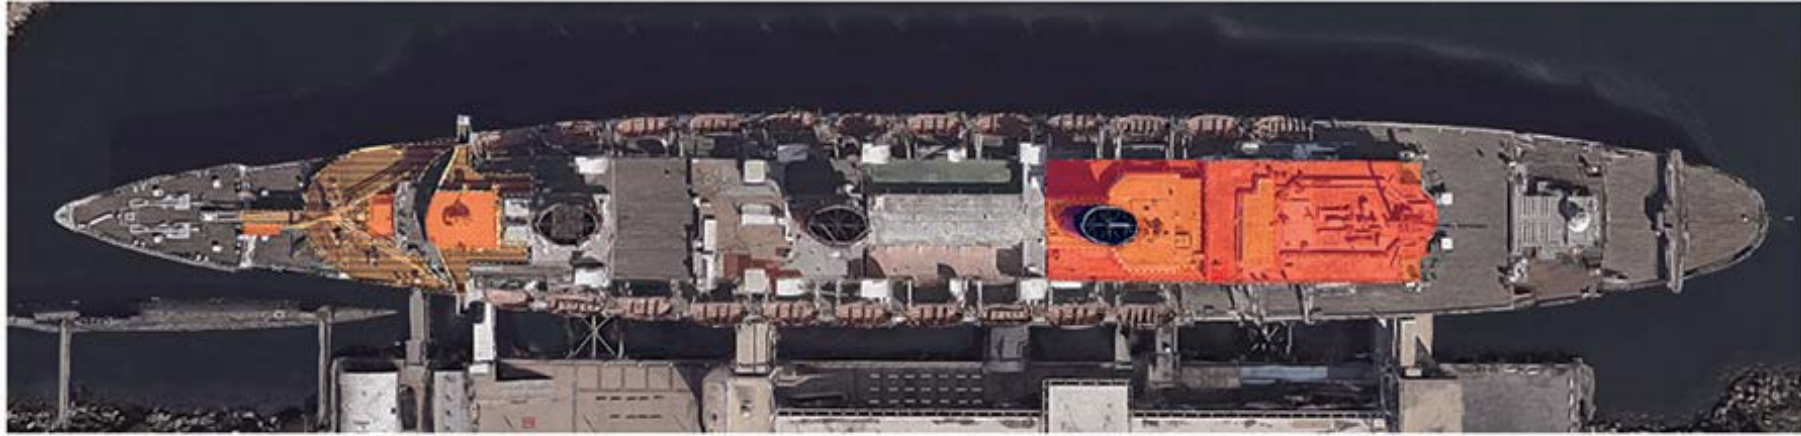
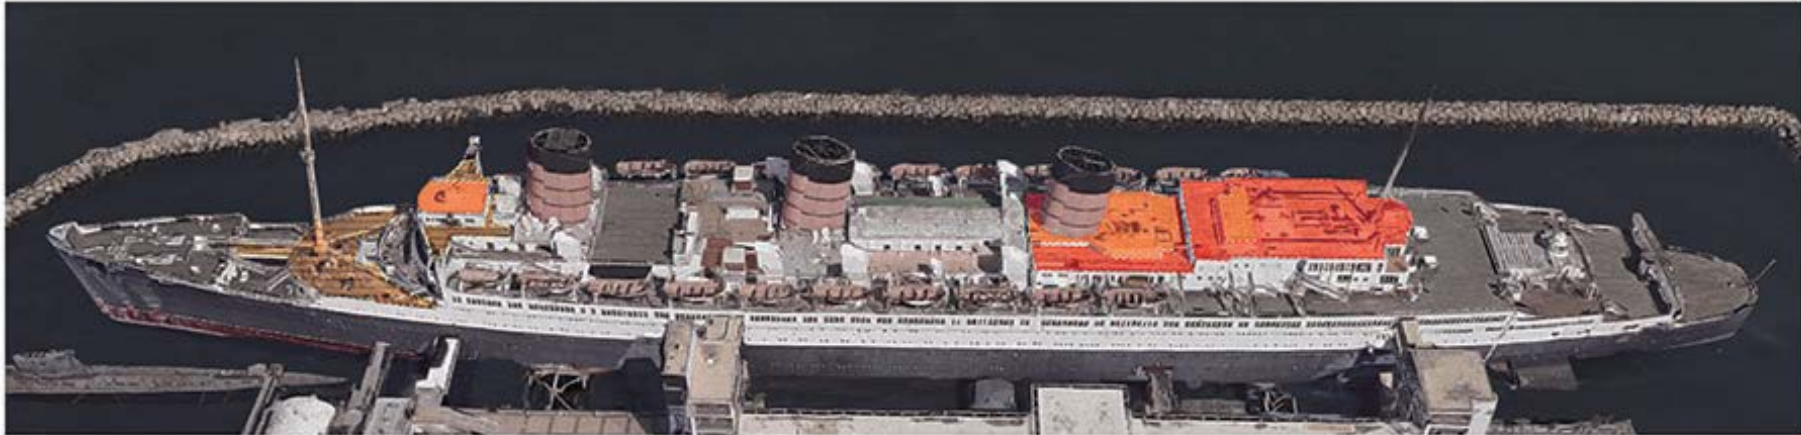
## Roofing and Deck Repair Areas

Roof damage and repair/waterproofing on Bridge deck (above Captain's Quarters)

~9,000 SF – New decking, incl. new steel substrate and new waterproofing

~15,000 SF – New roofing system, incl. new steel substrate
