Subject: **Queen Mary Update**

QUEEN MARY

INSPECTION REPORT

REPORT DETAILS			
Document Number	L-HO-M10-030760-R04	Client Name	POLB
Revision	A	Client Reference	
Author	Sergiu Borsan	Issue Date	23-Jun-2023
Task Name	Inspection Report	Task Number	CTR 105

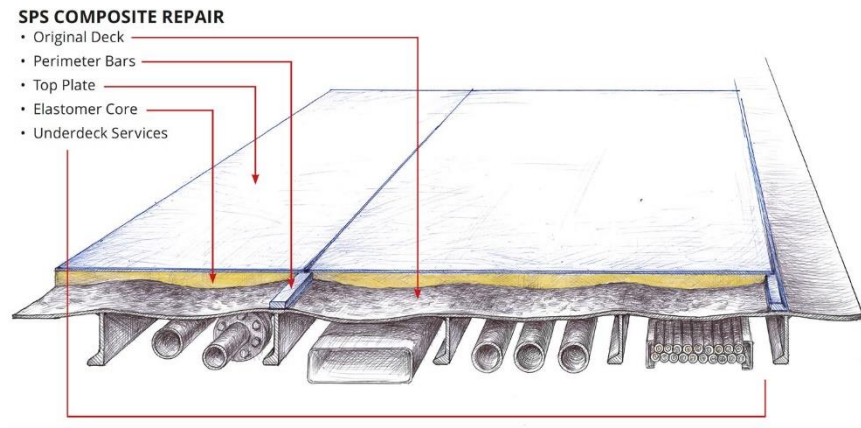
Figure 5-3: SPS Repair Example

To maintain the watertight integrity of the hull, the soft patch should be repaired. If the soft patch is compromised allowing for water ingress, the entire engine room could flood. Since there are no watertight doors to separate compartments, the vessel could flood until grounding.

It is recommended to repair the soft patch by means of Sandwich Plate System (SPS).

SPS is a Class approved repair method that introduces an elastomer core supported by perimeter bars over the existing plate. New steel plate is added on top of the core (See Figure 5-3)

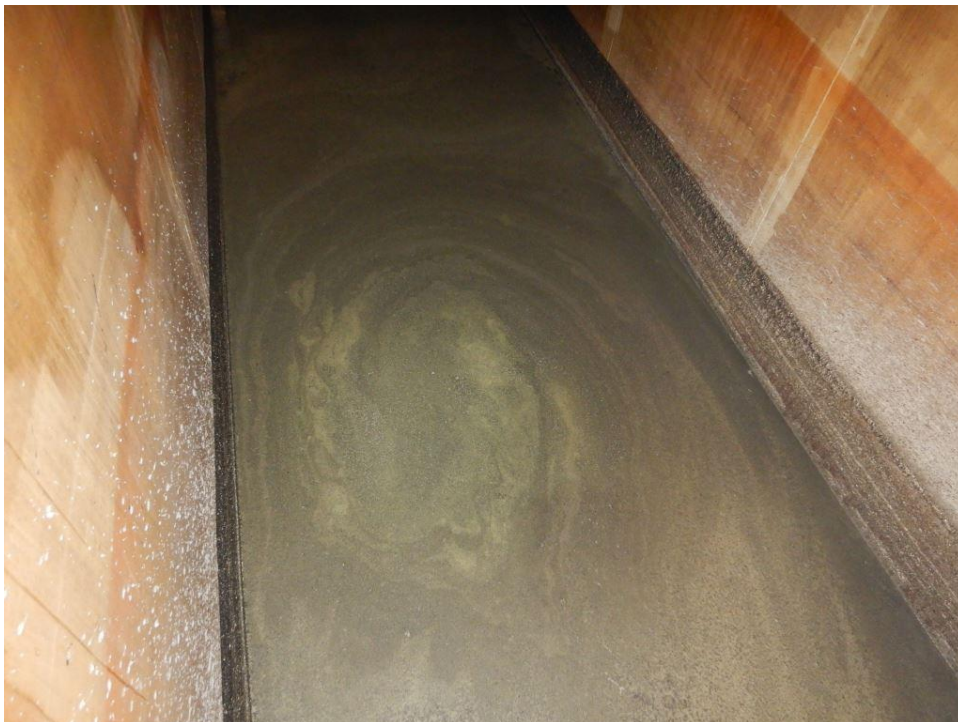
Figure 6-4: Diluted Mud in Frac Tank

The mud tanks had a stratum of 6-8 inches of fresh water sitting on top of the drill mud contents which allowed liquefaction in the initial stages of a pump transfer. Once this original stratum of fresh water was removed from the mud tank, new water had to be introduced to stimulate liquefaction of the contents. On average, around 4,000 - 5,000 gal of water were introduced in each tank to completely remove all mud contents.

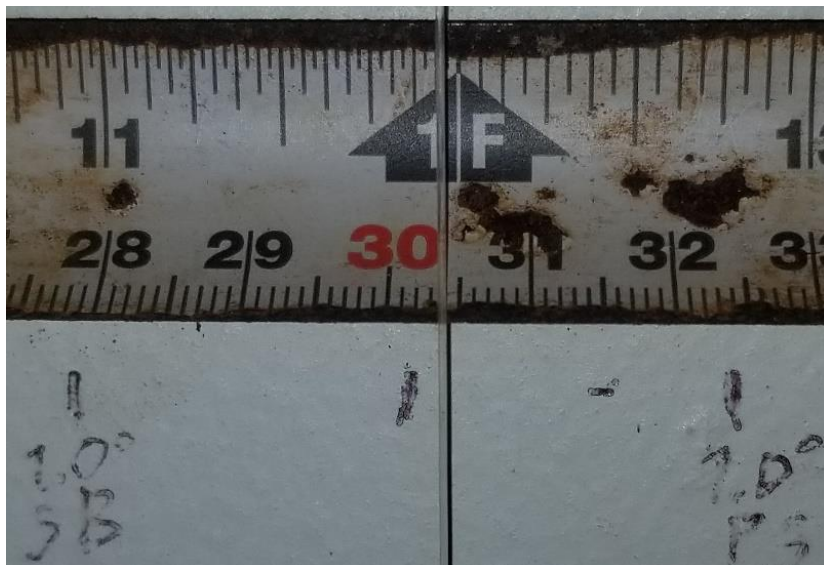
Figure 6-6: Pedulum Reading 30.4 cm (0.16 deg to PS) - Vessel Post-Operational condition

A pendulum measuring system for measuring the vessel listing was installed by CONSULTANT in the tool storage room of the QM on C deck. The system was calibrated where 1 cm is the equivalent of 0.4 degrees of list in either direction with 30cm corresponding to even keel. (Figure 6-6)
