This **DRAFT** section of the Long Beach Historic District Design Guidelines is part of a larger document created as a planning tool for the City's historic districts. The guidelines are intended to provide recommendations, inspiration, and advice as part of an instructive framework that will help guide sensitive changes to historic properties and encourage rehabilitation. By their nature, design guidelines are flexible. As such, outcomes may depend on the resource, the surrounding district, and the goals of the proposed project.

## California Heights

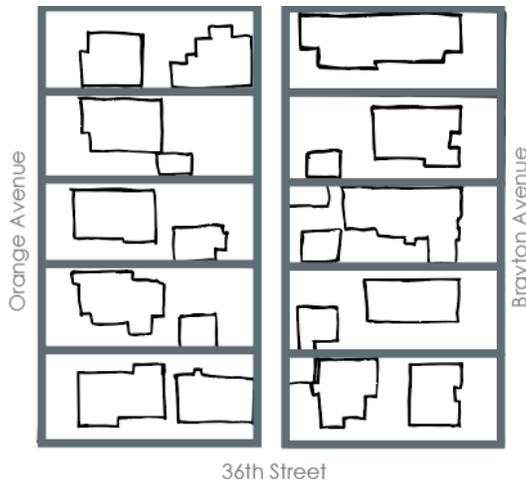
*Caption: The lots in the California Heights Historic District are rectangular and quite uniform in size.*

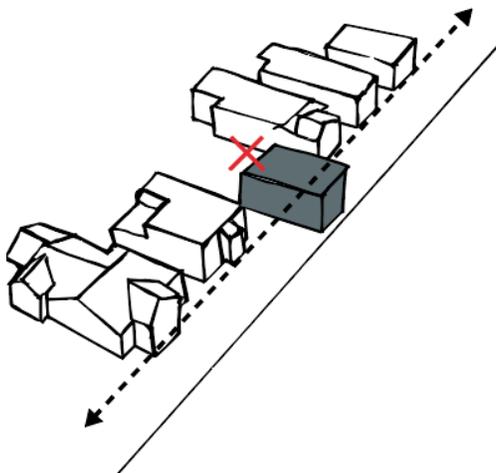
*Caption: Altering the front setback (indicated with a red "x") would cause a visual disruption in the district and is not permitted.*

The contributing buildings within the California Heights Historic District have a generally consistent setback of approximately 25' from the street. Some properties may have setbacks that are less than 25', but the majority have a setback of around 25'.

Any change to the setback from the street on the primary elevation could cause a disruption in the visual continuity of the district or the historic relationship of a building with its site, and is not permitted. Furthermore, a change in setback may not be permitted by the City's zoning code.

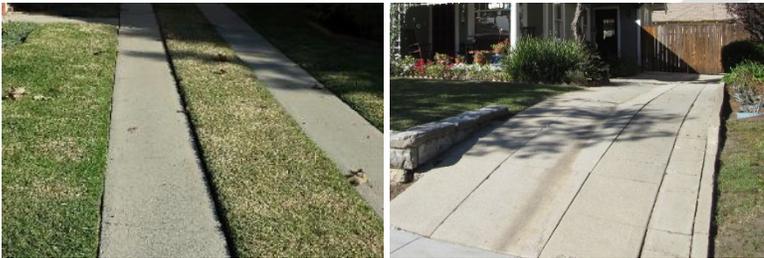
*Caption: There is evidence to suggest that the driveways in California Heights were once dual-ribbon (left); however, many have been converted to a single concrete slab (right).*

Otherwise, a historically compatible slab or dual ribbon driveway with scored joints should be installed. The two strips of a dual ribbon driveway may be separated by grass or loose rock, such as crushed quartz or river rock.

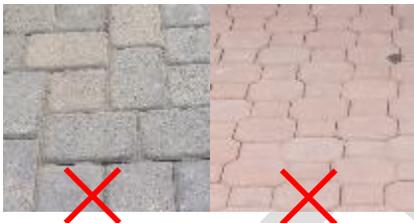
*Caption: Contemporary concrete pavers are not appropriate for use in the California Heights Historic District.*

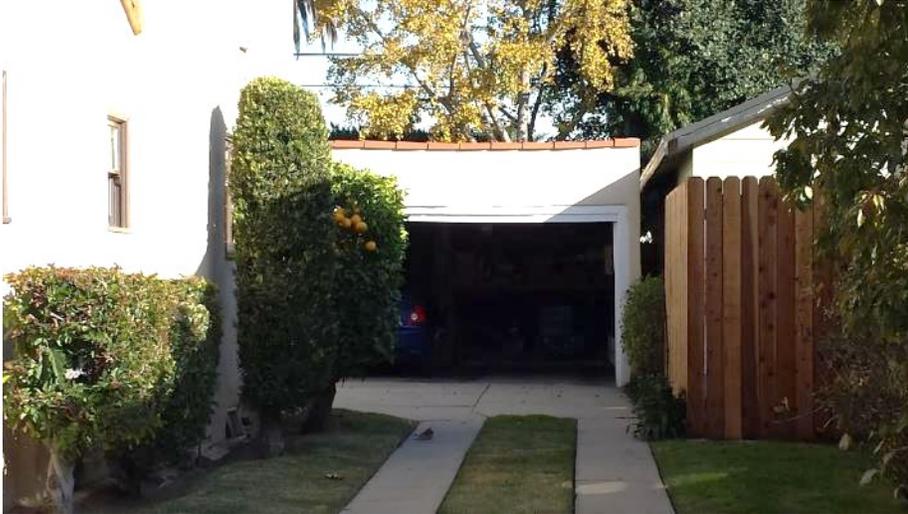
*Caption: An existing detached garage in the California Heights Historic District.*

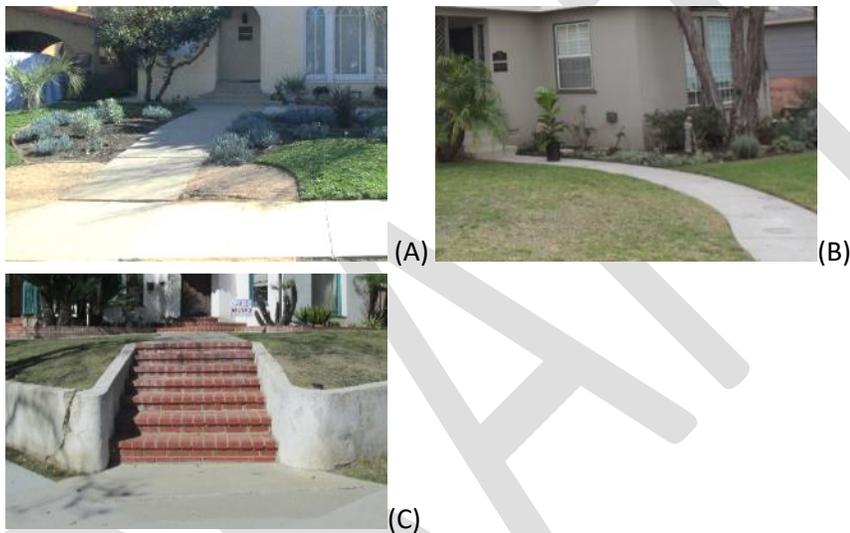
*Caption: Walkways in the California Heights Historic District are varied, depending on the style and date of the house, as well as the characteristics of the lot. Some examples of walkways include a straight, concrete walkway (A), a curving concrete walkway (B), and a brick and concrete walkway ending in stairs (C).*

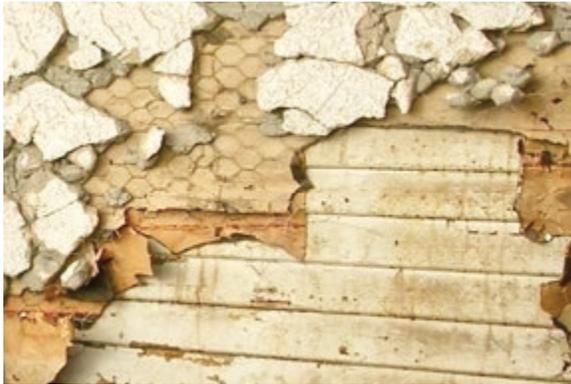
*Caption: This image shows original wood siding that was incompatibly covered in stucco.*

Original wood siding should never be replaced or covered with a new or different material that did not exist historically, such as brick or stucco. Where wood siding has been replaced or covered with a new building material, restoring historically appropriate wood siding when the existing cladding has reached the end of its useful life, rather than replacing or repairing the non-original material is encouraged.

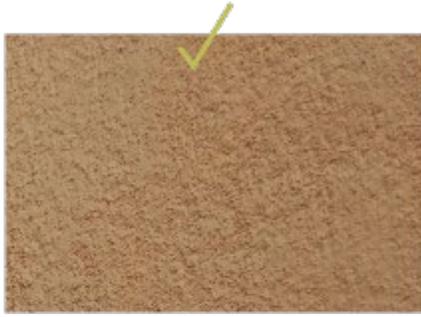
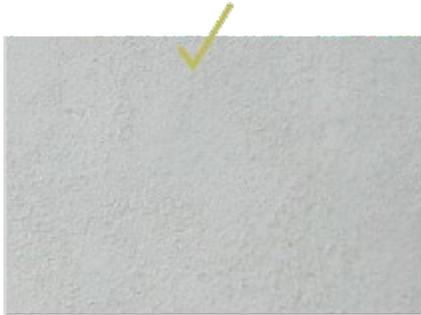
*Caption: An appropriate float or dash finish stucco has a slightly rough, sandy texture.*

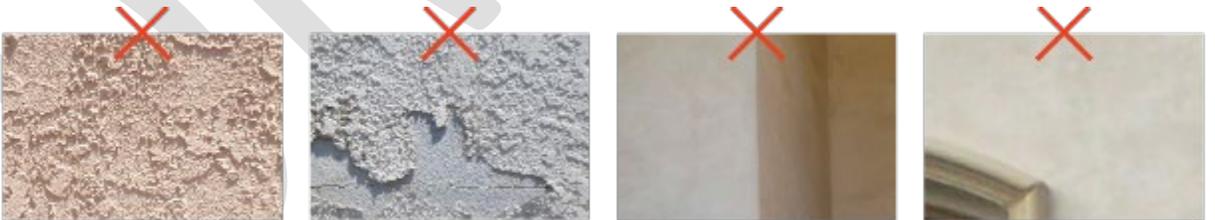
*Caption: Heavily textured "lace" finish stucco (left) or extremely smooth stucco (right) are equally inappropriate stucco finishes for historic buildings, and should not be applied.*

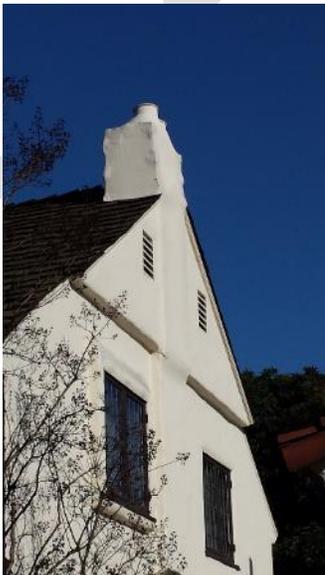
Many contributing properties in the California Heights Historic District have original chimneys. The chimneys are made of various materials, but are typically masonry. Some are clad in stucco.

*Caption: A chimney on a contributing property in the California Heights Historic District.*

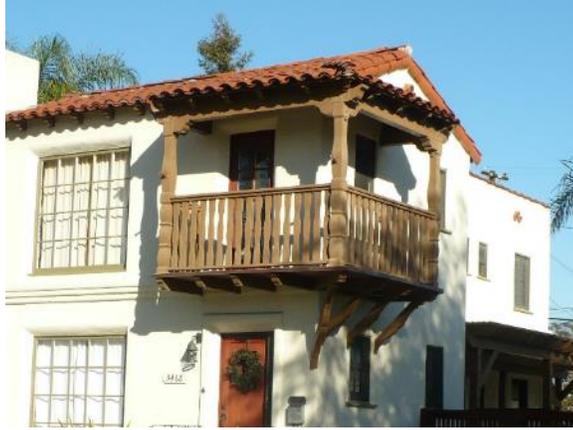
Similarly, an original **balcony** or **balconette** visible from the public right of way should not be removed or enclosed.

*Caption: A balconette on a contributor in the California Heights Historic District.*

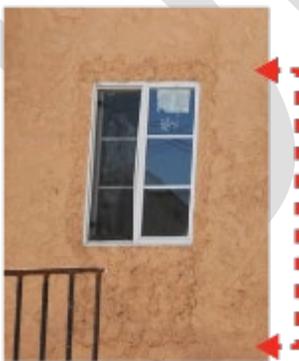
*Caption: Changing window openings can leave "scars" on the exterior of a building. Red arrows indicate the original extent of the opening.*

The size of a window opening should never be altered to accommodate a new window; rather, the window should be sized to fit the historic window opening.

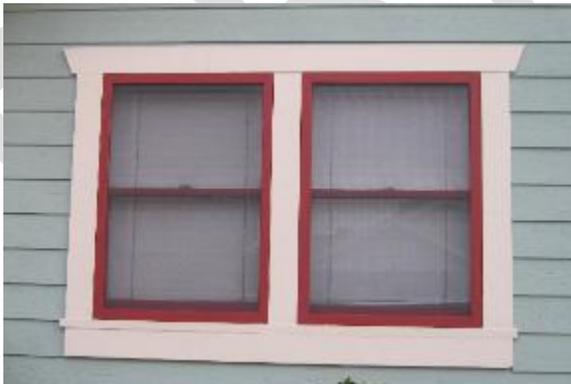
*Caption: This compatible window screen is sized to the window and has a narrow wood frame painted to match the building's trim.*

Window screens sized to match the original windows that have narrow, wood frames and are painted to correspond with the building's trim are recommended. The screen itself should be relatively transparent, and should not obscure the window behind it. Retractable screens may also be acceptable. Aluminum-framed screens are discouraged; vinyl-framed screens are not permitted.

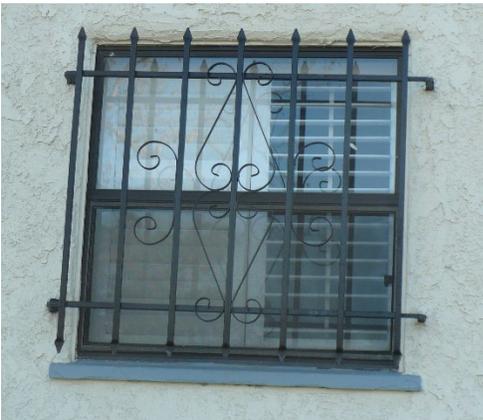
*Caption: Security bars are visually obtrusive and incompatible. Other security measures are encouraged.*

Consider less visually obtrusive security measures such as interior locks, swing-away interior mounted security bars, and wireless security sensors, where feasible. This equipment should be installed carefully so as to avoid damaging historic windows, even from the interior. Damage, especially to wood windows, may leave the window susceptible to deterioration.

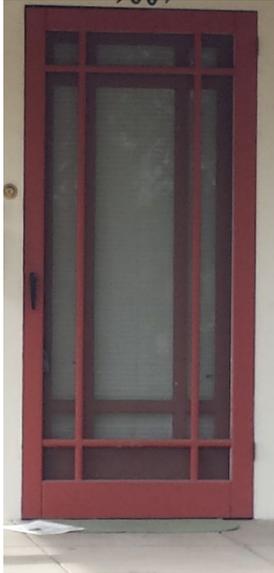
*Caption: This is an excellent example of a compatible screen door. The narrow wood frame is stained in a neutral color and the mesh enclosure is transparent enough that it does not obscure the door beneath it.*

Installing a **storm door** (glass enclosure) or **screen door** (mesh enclosure) may be acceptable if the feature is sensitively designed and carefully installed. Storm or screen doors that are sized to match the original door, have narrow, wood frames, and are painted to correspond with the building's trim or primary door are recommended. The screen or glass itself should be relatively transparent, and should not obscure the door behind it. Metal-framed screen or storm doors are discouraged. Vinyl-framed screen or storm doors are not permitted.

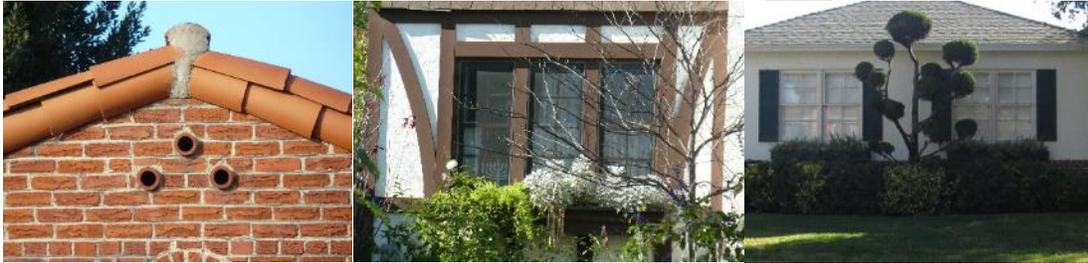
The contributing properties in the California Heights Historic District vary in styles; however, they are not highly ornate. For example, ornamentation on a Minimal Traditional residence would typically be limited to simplified traditional detailing, such as window shutters. Decorative features on Period Revival styles in the district may include features like half-timbering on a Tudor or French Revival, or clay attic vents or stucco niched on a Spanish Colonial Revival. Existing decorative features, where they exist, should be retained and repaired as needed, and replaced in kind if they are demonstrably damaged beyond repair.

*Caption: Existing decorative features in the California Heights Historic District.*

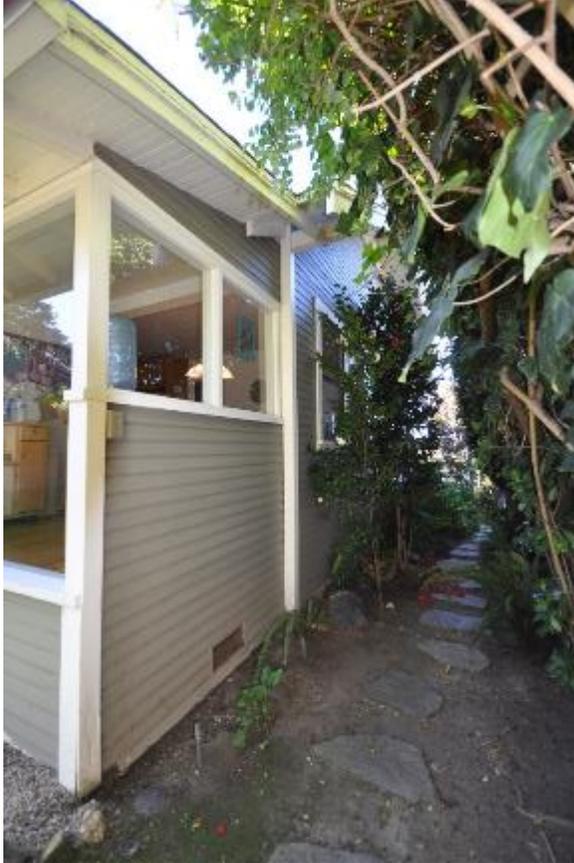
*Caption: This compatible addition is differentiated from the main house by fixed single-light windows and a vertical strip of trim.*

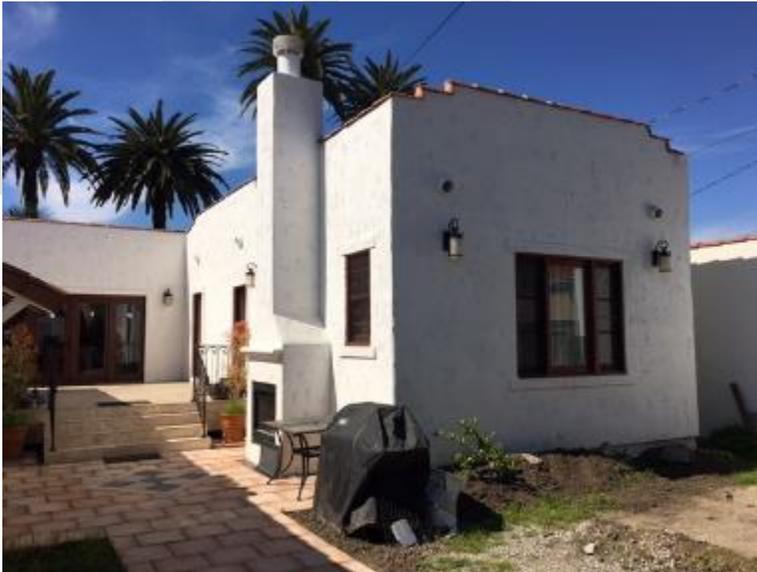
*Caption: This compatible addition is differentiated from the main house with a stepped roofline, slightly different yet compatible windows, and slightly differentiated window surrounds.*

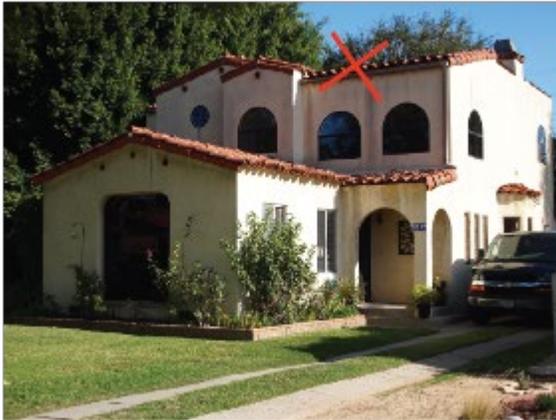
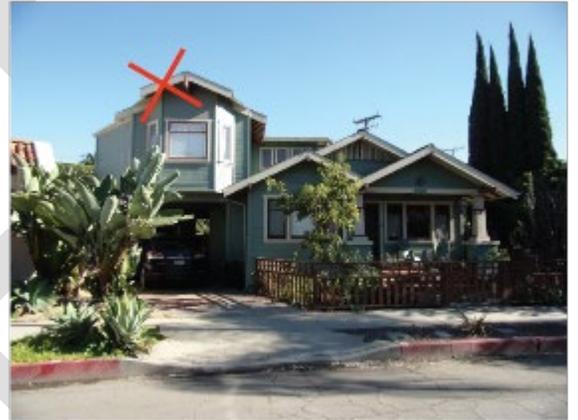
*Caption: The additions shown above would not be permitted. They are arranged near the front of the building, making them highly visible from the street and detracting from the original historic home.*

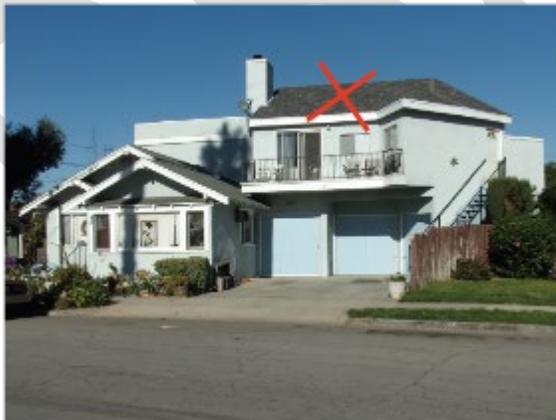
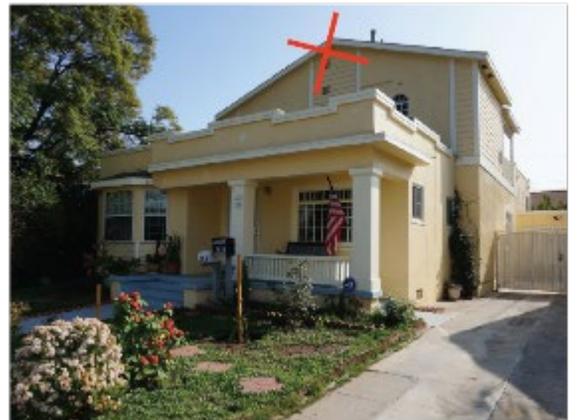
*Caption: The additions shown above would not be permitted. They are arranged near the front of the building, and introduce an incompatible roofline that is not in keeping with the original house form.*

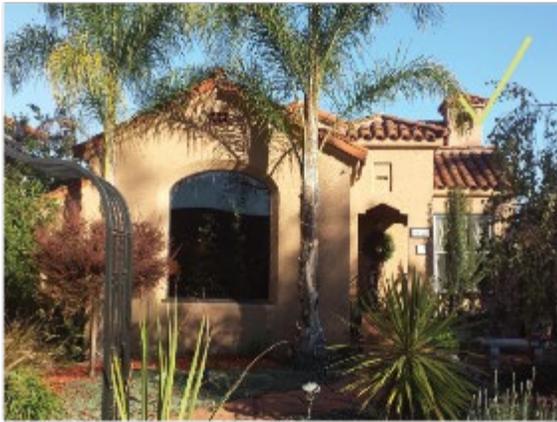
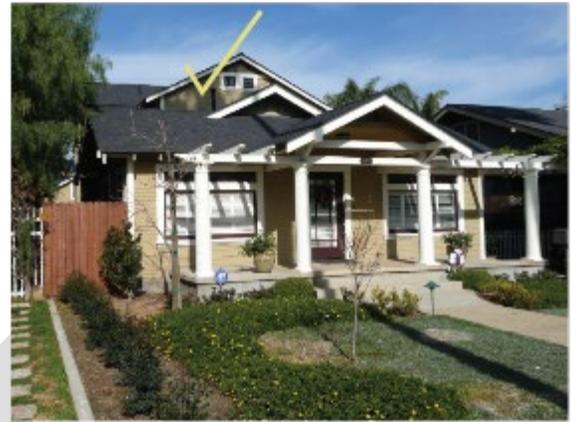
*Caption: The additions shown above are acceptable. They are oriented towards the rear of the building and complement the original house form, making them less visible from the street and more compatible.*

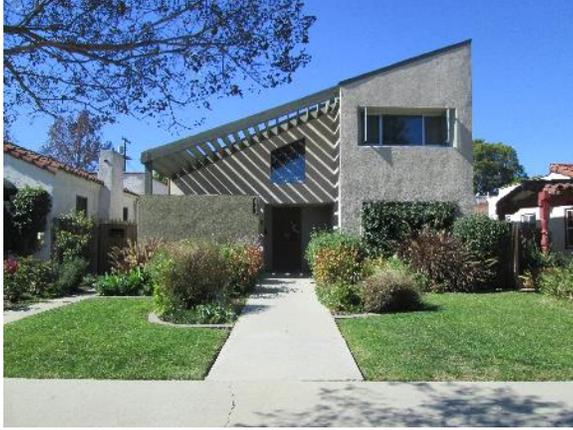
**Least compatible (3759-61 Lewis Ave):** This residence was constructed outside the period of significance and is the least compatible of these examples. It introduces a number of visual elements to the district that are not compatible with the surrounding contributors, including its contemporary massing with a highly visible shed roof, two-story height at the front of the building in a predominantly one-story district, and contemporary design elements including brise-soleils and geometric, non-traditional window shapes. While the design of the building does not draw from any of the contributing buildings surrounding it, it does have a front lawn, setback, and central walkway that help to maintain the visual cohesion of the district.

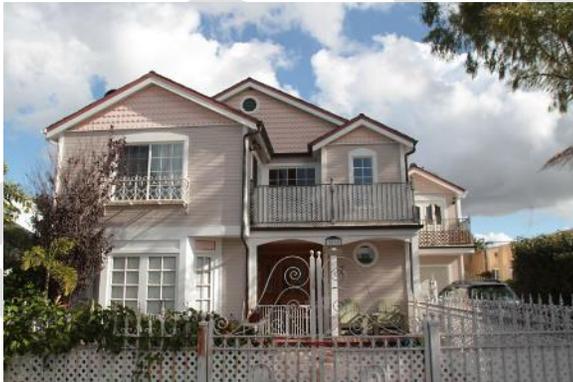
**More compatible (3558-60 Falcon Ave):** This residence was also constructed outside the period of significance. Like the above example, it is two stories in height with its massing oriented towards the front of the building, creating a visual disruption in a district that is predominantly one story in height. However, the design of the building includes more traditional details like horizontal wood cladding and gabled roof forms that help it to blend in more readily with the surrounding contributors and historic character of the district.

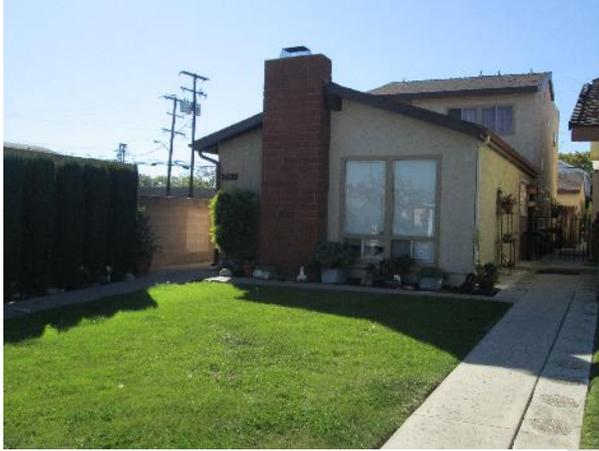
**Most compatible (3439 Cerritos Avenue):** This residence is the most compatible of the three examples. It is two stories in height, but the upper story is oriented towards the rear, making it less visible from the street. The front of the building is one story in height with a gabled roof form and traditional brick chimney. The building is clad in stucco and wood, and the property has a front setback and landscaped yard, helping it to blend in more readily with surrounding contributors and historic character of the district.
